Failure Analysis & Mechanism Studies of the Worm-like Defects in Vias of Wafer Fabrication

Hua Younan*, Liao Jinzhi Lois, Liu Binghai, Zhu Lei, Li Xiaomin

WinTech Nano-Technology Services Pte. Ltd., 10 Science Park Road, #03-26, The Alpha Science Park II, Singapore 117684

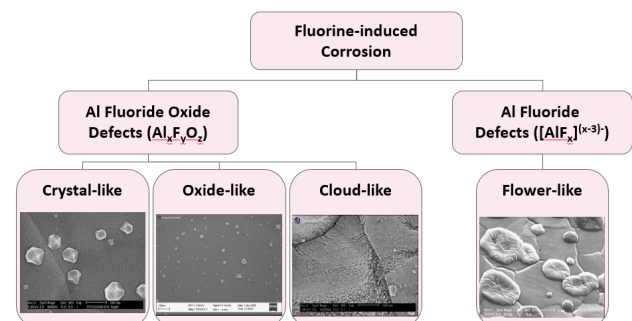
Figure 1: The F-induced corrosion defects were classified as the “flower-like”, “crystal-like”, “oxide-like” and “cloud-like” defects.

For example, we have deeply studied the F-induced corrosion defects and proposed the related failure models, and made classification for the F-induced corrosion defects on the Al bondpads as the “flower-like”, “crystal-like”, “oxide-like” and “cloud-like” defects as shown in

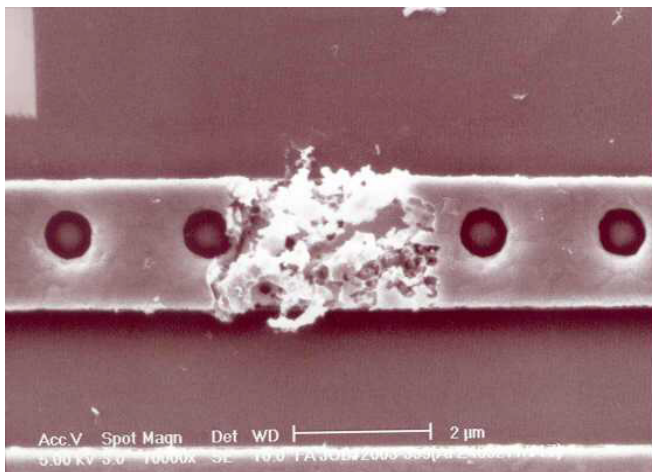
Figure 2: SEM micrograph showed the corrosive defect on Al metal line due to Cl-induced corrosion.

Figure 2 shows a Cl corrosive defect on the Al metal line. One can see that the defect has damaged the metal line, which may cause low yield or reliability issue. The root cause was identified to be Cl environment contamination. It is understood that differencing from F-induced corrosion, Cl-induced corrosion is immediate. Moreover, AlCl₃ is a chemically unstable compound and it dissolves in water. Therefore, Cl-induced corrosion is more serious as it can cause chemical chain reactions (see discussion in the next session).

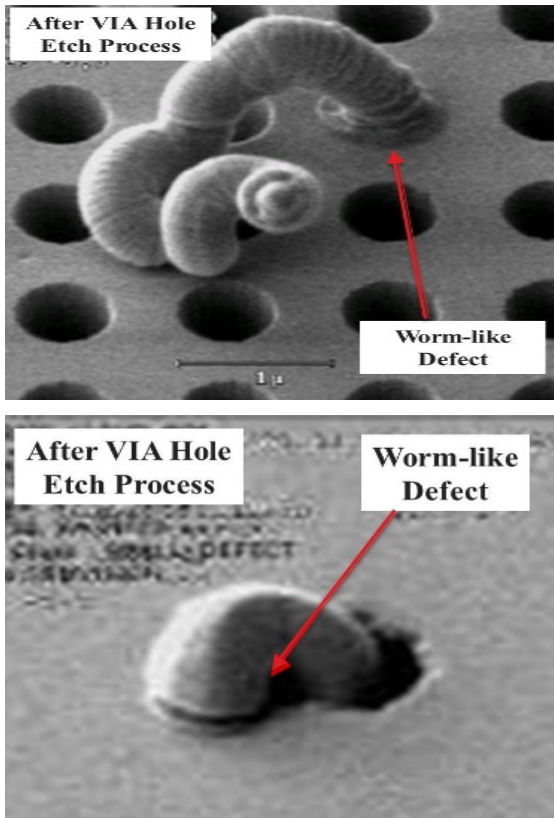
Inline SEM inspection after VIA hole etch process revealed the formation of bountiful worm-like defects, protruding from via holes, as shown by the SEM images in Figure 4. With the presence of these worm-like defects will definitely affect the subsequent processes like deposition of the barrier layers and W layer. In order to the understand the root-cause behind the formation worm-like defects, we performed detailed failure analysis and failure mechanism studies.

Figure 4: The Worm-like defects were found in Via holes after Via hole etching processes in wafer fab. At the bottom of the via holes, it was Al M1.

As the topmost wafer is the most exposed wafer, it is also the most severely affected, hence producing the “first wafer” effect. These observations reinforce the theory that corrosion is due to SMIF pod contamination. A feasible solution therefore is to eliminate the possibility of pod switching between a pod used for Cl-based etch process and a pod with exposed Al metal.

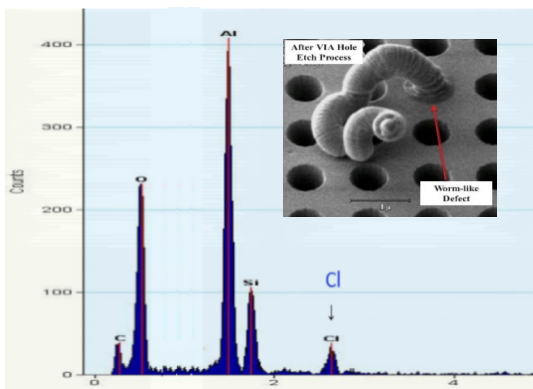
Figure 5 shows the micro-area EDX analysis on the worm-like defect. As shown in Figure 5, a small amount of Cl was detected, indicating that the worm-like defect was formed due to Cl-induced corrosion. Further FIB-SEM analysis showed that the worm-like defects directly grew from the bottom Al M1 layer along the via holes.

Figure 5: EDX on the Worm-like defect detected Cl peak and confirmed that it was Cl-induced corrosion defect.

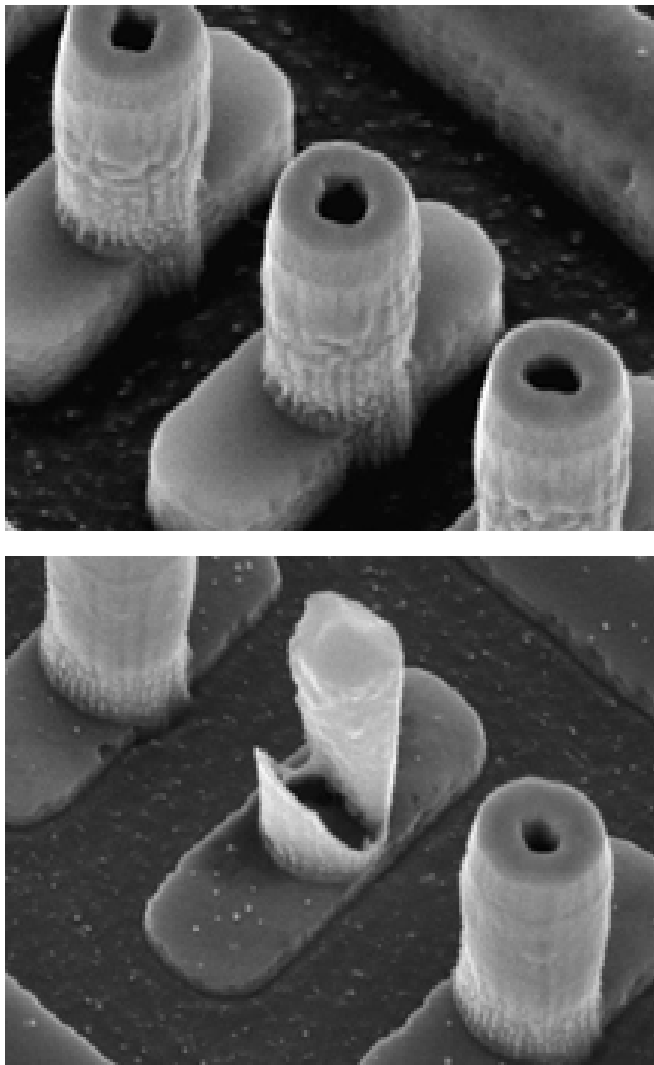
Figure 6: The delayering results showed in good area, the Vias had good metal filling (up), but in bad area, partial via filling was observed due to the worm-like defect (down).

For the failure via structures, we performed the failure analysis by deprocessing (delayering), and then top-down and cross-sectional SEM analysis. Figure 6 showed the top-down SEM images after deprocessing. As shown by Figure 6, the good Vias essentially showed good metal filling (up of the Figure 6), but in the bad area, one Via showed apparent partial filling due to the worm-like defect (down of Figure 6).

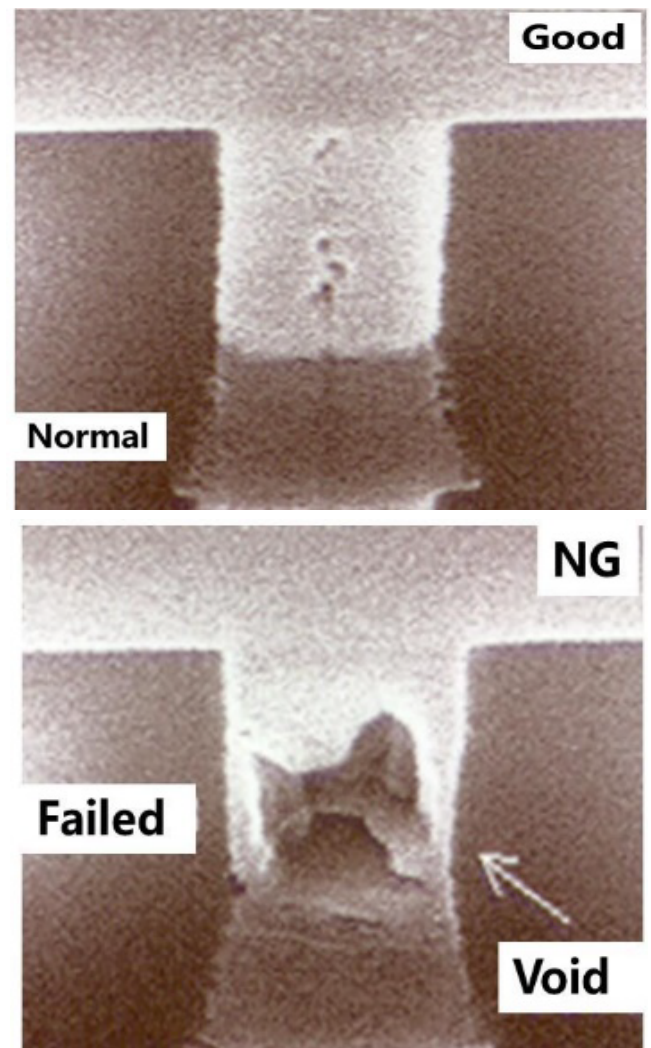
We also performed cross-section FIB (focused ion beam)-SEM analysis. The cross-sectional SEM analysis results were shown in Figure 7. It is clear that the via in the affected lots showed partial filling with a big void at the via bottom (down of the Figure 7) and the FIB-SEM result showed that in the good sample without the worm-like defect, the Via was completed to fill in (up of the Figure 7).

Figure 7: FIB cross sectional result showed that in the good sample without the worm-like defect, the Via was completed to fill in (up). But non good (NG) sample with the worm-like defect, the Via was not completed to fill in and with the void (down).

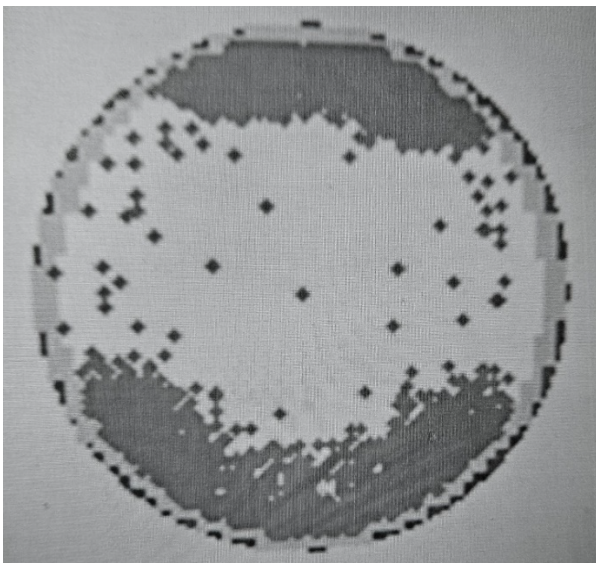
Inline investigations and analysis reveal interesting characteristics of the worm-like defects. KLA scan maps of the affected wafers showed a distinct bracket signature (refer to Figure 8). There was also no single wafer orientation or alignment with respect to the notch. Another characteristic was that the first slot was typically the most severely affected wafer compared to the rest of the wafers in the lot. It has also been observed that the occurrence of the worm-like defects was intermittent with no common tool, device/part, or layer. It also occurred even with environmental Cl levels safely below the specification limit.

Figure 8: KLA scan map of the wafer affected with the worm-like defects showing bracket signature.

The distinct bracket signature in KLA scan maps matches the exposed sections of the wafers when placed inside the cassette (see Figure 4). In other words, only those sections exposed to the SMIF pod are affected with worm-like defects.
