A Study on the Bromine-induced Corrosion/Defects in Wafer Fabrication

Hua Younan, Liao Jinzhi Lois, Zhu Lei, Liu Binghai, Li Xiaomin

WinTech Nano-Technology Services Pte. Ltd., 10 Science Park Road, #03-26, The Alpha Science Park II, 117684, Singapore

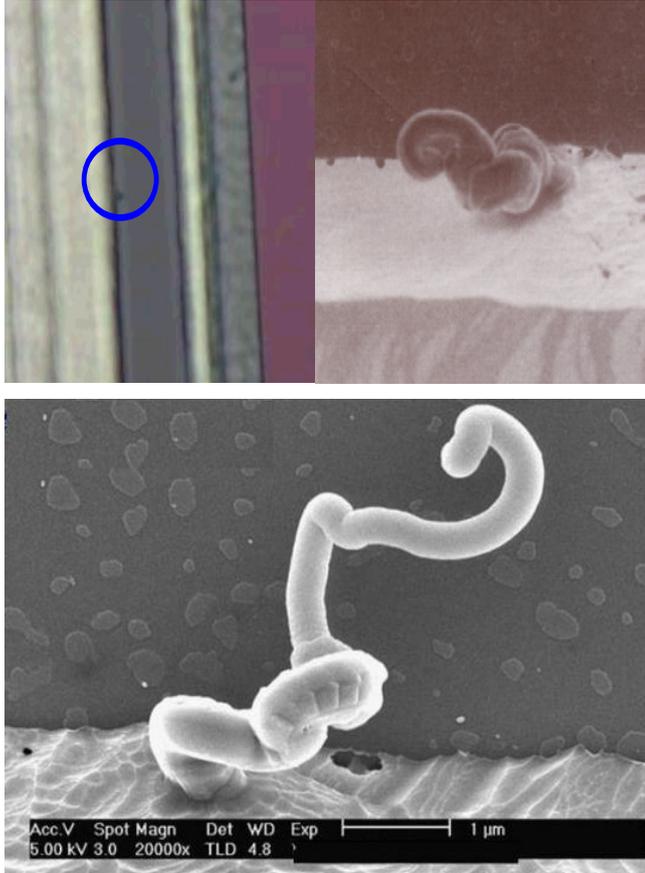
The worm-like defects were caught by the inline YDD (yield defect density) after Al metallization processes. The inline defect map indicated that the defects were mainly in the wafer edge regions. Under the optical microscopy, the defect was shown as a small dot-like (the circled in Figure 1(a)), mainly existed along the edge of the Al metal lines. Further SEM analysis clearly showed that these small defects appeared as the worm-like, as shown in Fig.1 (b) and (c). These worm-like defects significantly impacted the quality and yield of the wafer fabrication process. Consequently, we proceeded to conduct a failure analysis and investigate the underlying mechanisms using various analytical techniques such as AES, SEM, EDS and ion chromatography (IC).

Figure 1: The worm-like defects were found on the sidewalls of Al wires in wafer fab process.

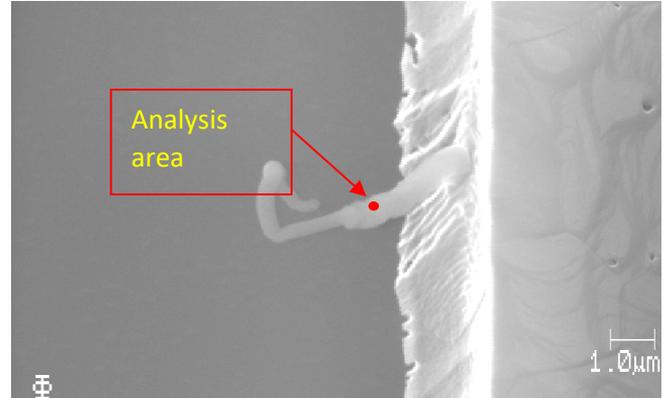
The AES wide scan was done on a worm-like defect and analysis area was shown in Figure 2. The AES wide scan results were depicted in Figure 3 (as received), Figure 4 (after 2nm sputtering) and Figure 5 (after 5nm sputtering), revealed the absence of any halogen element on the surface of the worm-like defect.

Figure 2: The AES wide scan was conducted on a defect resembling a worm, precisely located at the indicated spot by the arrow.

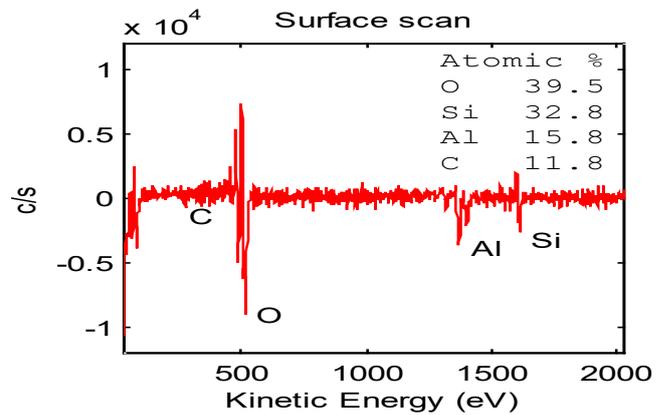
Figure 3: AES analysis (As received) result showed no traces of halogens elements were detected on the worm-like defect.

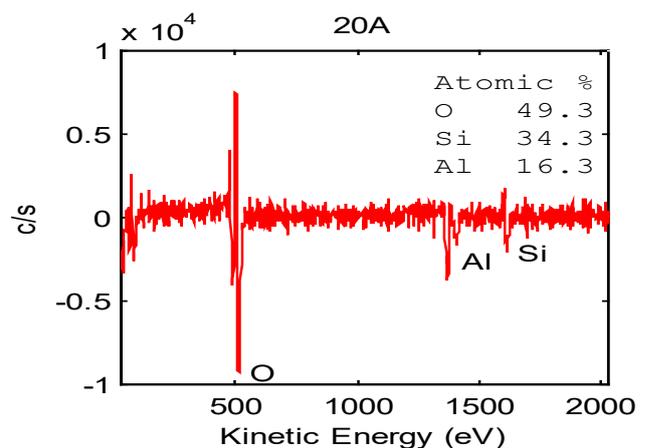
Figure 4: AES analysis (After 2 nm sputtering) showed no traces of halogens elements in the worm-like defect.

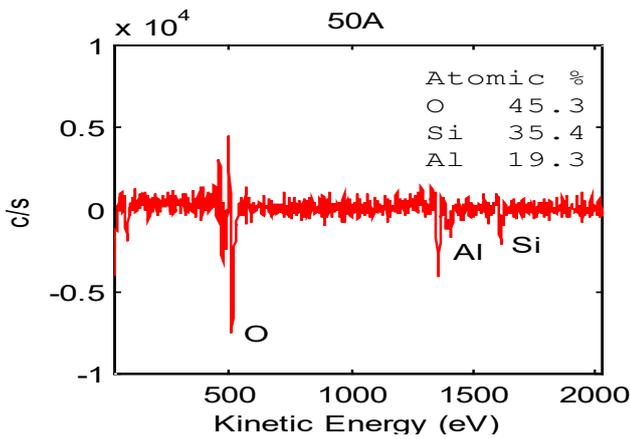
Figure 5: AES analysis (After 5 nm sputtering) result showed no traces of halogens elements were detected on the worm-like defect.

1. The AES spectrum exhibits overlapping peaks for both bromine (1393 eV) and aluminium (1396 eV). This overlap creates a mere 3 eV difference, making it impossible for us to distinguish between these peaks accurately.
2. The compound $AlBr_3$, which includes bromine, is known to be water soluble. Therefore, we suspect that the $AlBr_3$ present on the surface of the worm-like defects may have been washed away during the wafer fab process.
3. Additionally, it is important to note that AES analysis solely provides information about the composition of the surface of the worm-like defects. It does not provide a comprehensive analysis of the entire sample. Consequently, based on the AES results obtained, we cannot definitively rule out the presence of bromine in the worm-like defects.

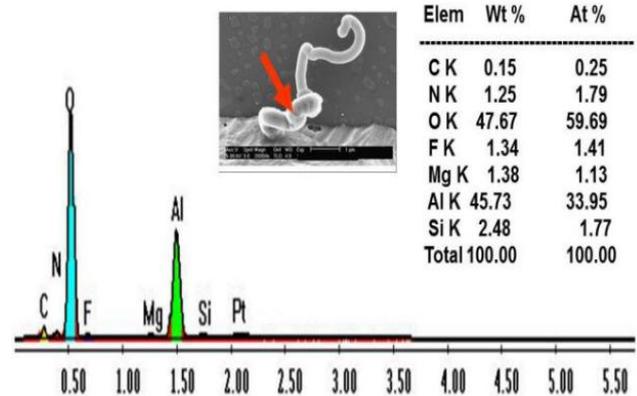
SEM/EDS analysis was performed at an acceleration voltage of 5kV, under which no chlorine (Cl) and bromine (Br) were detected. However, low content of fluorine (F) was detected, approximately 1.34 wt%, close to the detection limit of EDS, as shown in Figure 6.

Under 5 kV, the EDS is only capable of detecting the $L\alpha$ peak of bromine at 1.4805 keV. However, this peak is overlapped with the $K\alpha$ peak spectral line of aluminium at 1.4866 keV. Consequently, it is not possible to distinguish between these two peaks when using a 5 kV acceleration voltage. To identify the presence of bromine, we need to utilize the $K\alpha$ peak spectral line of bromine at 11.9089 keV.

Figure 6: EDS (5kV) not detected Cl and Br, only detected a trace of fluorine peak, which was about 1.34wt%.

With the above analysis, the reason behind the non-detectability of Br (see Figure 6) was clear. It turned out that the Br peaks were not excited at the acceleration voltage of 5kV. To exciting the Br $K\alpha$ line, we need to employ a higher voltage exceeding 17.86 kV, which is 1.5 times the energy of the $K\alpha$ line of bromine. Therefore, it is advisable for us to utilize an acceleration voltage of 20 kV in order to accurately identify the Br $K\alpha$ peak.

Henceforth, when conducting failure analysis through EDS in the future, we highly advise employing a combination of high acceleration voltage and low acceleration voltage simultaneously. By doing so, one can ensure the avoidance of any potential oversights in detecting elements.

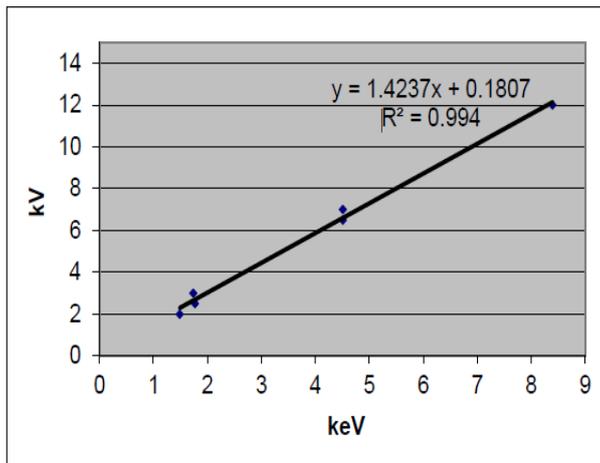
The experimental results were shown in Figure 7 which revealed a strong linear relationship between the accelerating voltage (V_i) measured in kilovolts (kV), and the energy (E_i) of the characteristic X-ray line of the specific element of interest, measured in kiloelectron volts

(keV). The over-voltage constant (k) was found to be approximately 1.42, as depicted in Figure 7.

Figure 7: Experimental result showed a good linear relationship between the beam accelerating voltage V_i (kV) and the energy of the characteristic X-ray line of the element interested.

Figure 7 showed clearly a linear relationship between the beam accelerating voltage V_i (kV) and the energy of the characteristic X-ray line of the element interested E_i (keV). For the general application purposes, the k is recommended to be 1.5. Therefore, the acceleration voltage estimation formula is shown below:

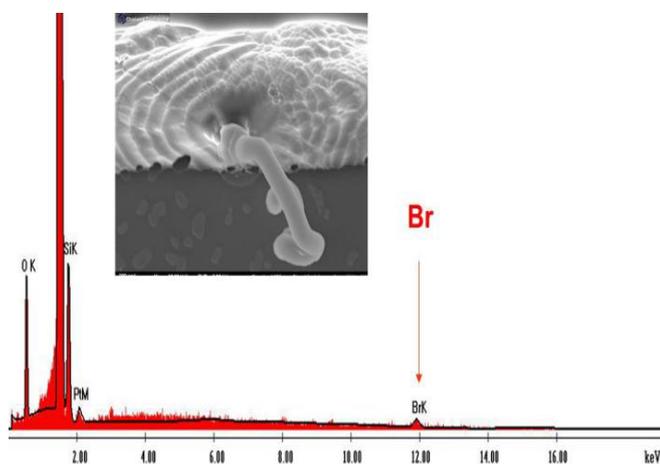
According to Eqn. (3), we understand that in order to excite the $K\alpha$ line of bromine (11.9089keV), the acceleration voltage of EDS must be higher than 17.86 kV (1.5x the energy of the $K\alpha$ line of bromine). Therefore, acceleration voltage of 20 kV is needed for the analysis of bromine in the worm-like defects. As a result, we detected the $K\alpha$ peak of bromine on the worm-like defect as shown in Figure 8.

Figure 8: EDS results of the worm-like defect at acceleration voltage of 20 kV showed that the $K\alpha$ line of bromine at 11.9089keV was detected.

The analysis conducted using high kV in EDS revealed the detection of bromine, thereby confirming its presence within the worm-like defects. The corrosion of aluminium wires and the subsequent formation of these worm-like defects were caused by contamination with bromine.

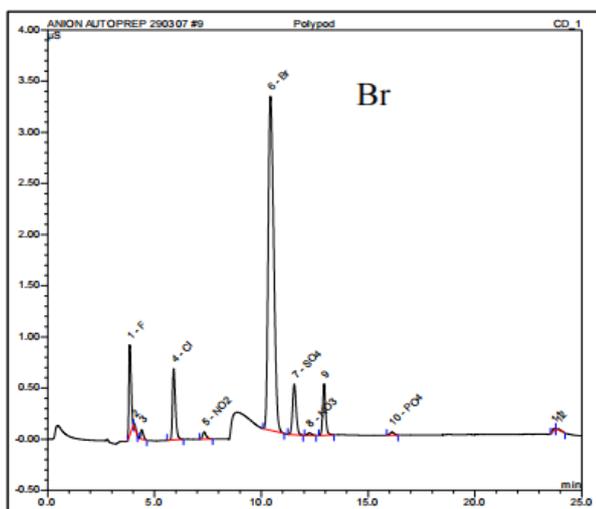
Based on the ion chromatography findings, the SMIF pod that was affected revealed the presence of F, Cl, and Br ions. Among them, the concentration of Br ion was the highest, measuring approximately 1.11 parts per million (ppm). Initially, the identification of bromide was challenging due to the detection of a broad peak at the same retention time as Br. This broad peak could be an

To validate the existence of Br, a diluted sample was prepared by mixing it with deionized (DI) water at a ratio of 100:1. After dilution, the broad peak was confirmed to be the Br peak. The IC spectrum in Figure 9 exhibits the diluted IC analysis of the affected SMIF pod.

The level of bromine pollution found in the previously utilized SMIF wafer cassettes (depicted in Figure 9) was roughly 70 times greater when compared to the fresh SMIF wafer cassettes (depicted in Figure 10). The results obtained from the analysis of ion chromatography indicate that the affected SMIF pod was contaminated by Br during the wafer fab process. It is possible that there was cross contamination either from the surrounding environment or from the chemical solvents used in the wafer fab process, particularly during the Front-end-of-line (FEOL) processing stage. If the contaminated pod was used during the Back-end-of-line (BEOL) processing, it is likely that the presence of Br caused contamination in the metal lines, leading to Br-induced corrosion and the formation of the worm-like defects.

Figure 9: Ion chromatography analysis result showed high Br peak in suspected contaminated SMIF Pod.

It is highly suspected that the contamination with bromine occurred through cross-contamination between the front and backend processes via the SMIF pods. In response, the process engineer has implemented measures to control the use of SMIF pods between the front and backend processes and has introduced a cleaning procedure.

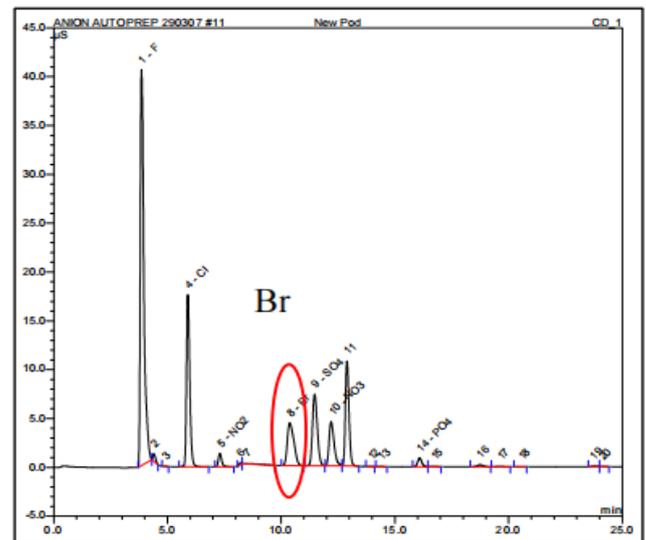
Similarly, a new pod underwent the same analysis, and a low level of Br was detected, measuring approximately 16 parts per billion (ppb). This concentration is significantly lower, around 70 times, compared to the affected SMIF pod. The IC spectrum in Figure 10 demonstrates the IC analysis of the new pod.

Figure 10: Ion chromatography analysis result showed low Br peak in a new SMIF Pod.
