Electrochemical Desalination Test of Bricks as a Building Material for Historical Buildings in Japan

Risako Fukami *, Toshiya Matsui

Faculty of Art and Design, University of Tsukuba, 1-1-1 Tennodai, Tsukuba, Ibaraki 305-8577, Japan

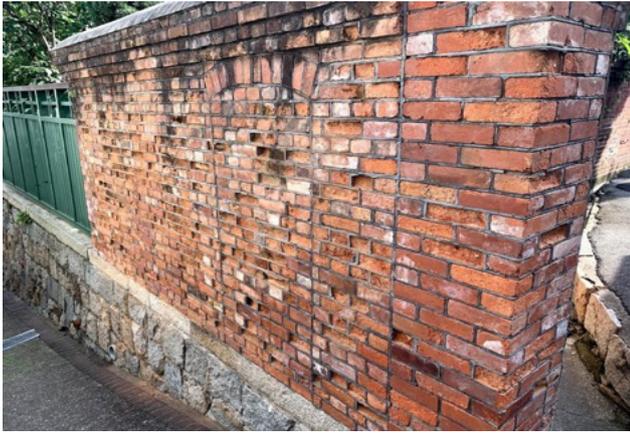
Figure 1: Buildings showing signs of deterioration due to salt weathering

weathering caused by the surrounding environment (Figure 1 and Figure 2) has been reported in various parts

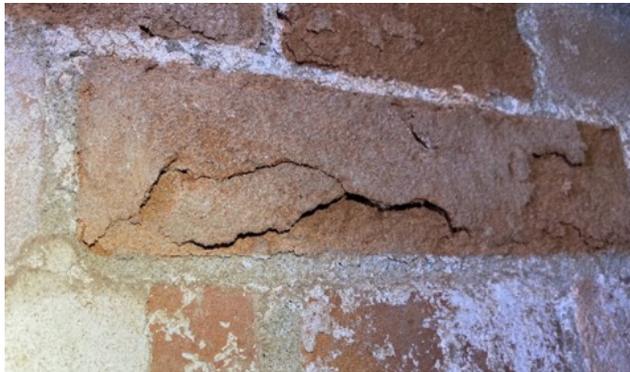
Figure 2: Bricks with peeling due to salt weathering

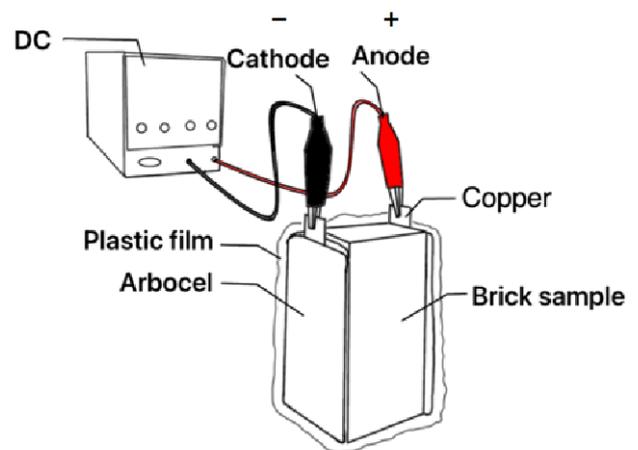
Figure 4: ED model (created by the author)

Powdered cellulose (Arbocel BC1000 from Holland Gwabo) and copper plates (Kenis) were used to create the electrodes. Arbocel is originally used as an inert filler for cleaning rocks and frescoes and for conditioning poultices and has hydrophilic and insoluble properties [18, 19]. The copper plate (15 mm in width, 45 mm in length) had a purity of 99.96%. To 25g of dried powdered cellulose, ultrapure water with an electrical resistivity of 18.2 MΩ/cm was added, amounting to 20% of the dry weight of the brick samples. The mixture was combined until the Arbocel was moistened. Since the absorption rate of the brick samples was 20% of the dry weight, this amount of water was determined to represent the saturated water content and added to the powdered cellulose. Moistened Arbocel was placed on two sides and bottom of the brick sample, and copper plates were inserted into the lateral Arbocel layers, so that the copper plates did not touch the brick material. The test was conducted on the smaller surfaces of the brick (5 cm × 5 cm), namely the top and bottom, and the electrodes were placed at the top of the two sides. The surface was covered with a plastic film to prevent the Arbocel from drying out (Figure 4).

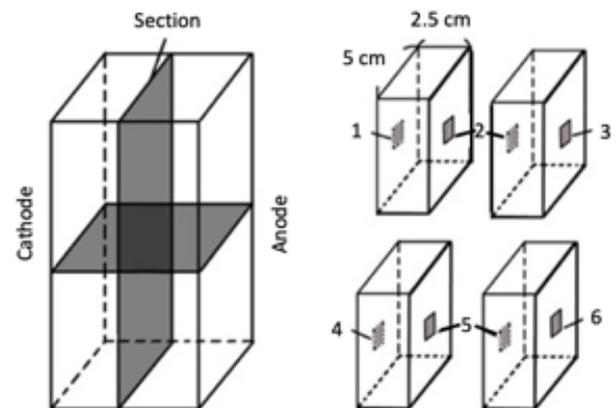
Figure 5: Schematic of the division of the sample (left) and the brick powder sampling point (right)

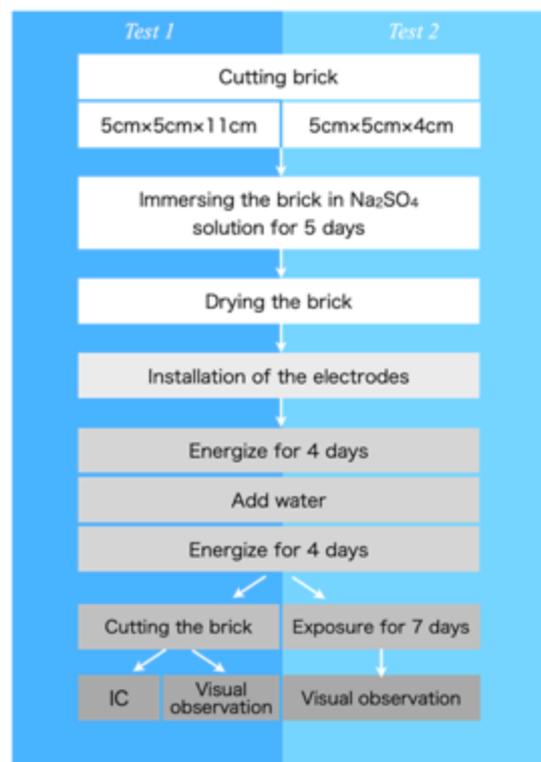
Figure 6: Flowchart of Test 1 and Test 2

were exposed to an environment with a temperature of 25°C and a relative humidity of 60% for 7 days after being energized following the same procedures than those of Test 1. The same current-carrying conditions (5 V, 0.5 A) both with and without the addition of ultrapure water during energization were also prepared (Table 2). The flowcharts for Test 1 and Test 2 are shown in Figure 6.

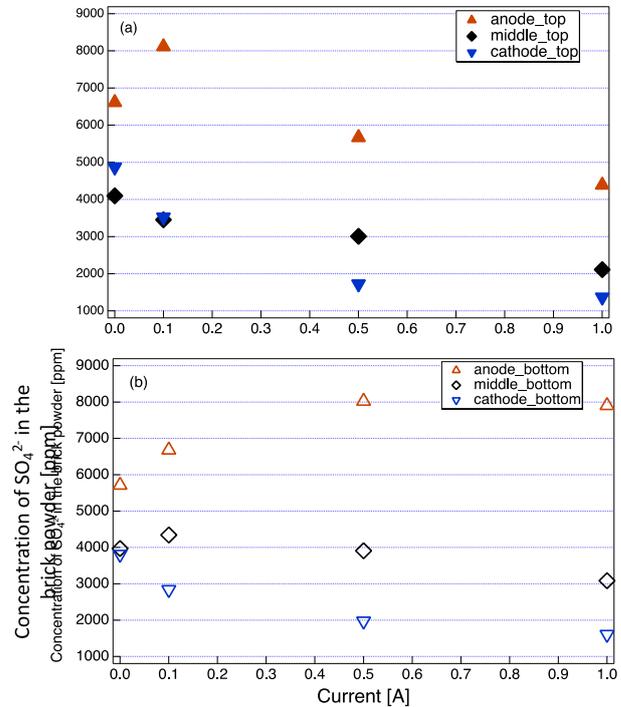
Figure 7: (a) Concentration of SO₄²⁻ in the upper part of the brick sample (b) Concentration of SO₄²⁻ in the lower part of the brick sample

The results of the ion chromatography analysis are described separately for the top and bottom of the brick samples. Regarding the top, the SO₄²⁻ concentration in the entire upper part of the brick samples decreased compared to that of the control sample when the current was applied at 0.1 A or higher. The decrease in SO₄²⁻ concentration in the middle and cathode side was especially pronounced when the energizing conditions were 0.5 A and 1 A. It was also found that under 0.5 A energizing conditions, SO₄²⁻ content in the brick powder collected from the top of the brick sample decreased by 35.5% compared to the control, and under 1 A, it decreased by 54.8%. However, as shown in Figure 7, SO₄²⁻ concentrations on the anode side were high, suggesting that SO₄²⁻ in the brick moved from the cathode to the anode, and some ions were removed from the brick by moving to the Arbocel on the anode side, while some remained on the anode side of the brick sample.

Regarding the lower part of the brick samples, there was no decrease in the SO₄²⁻ concentration in the entire lower part compared to the control brick sample, even when changing the current values. However, it was found that the SO₄²⁻ concentration on the cathode side decreased while it increased on the anode side when applying a current of 0.1 A or higher. Furthermore, when a current of 0.5 A or 1 A was applied, the SO₄²⁻ concentration decreased not only on the cathode side but also in the middle part (Figure 7). These results suggest that SO₄²⁻ in the lower part of the brick samples moved from the cathode to the anode when energization was applied under conditions of 5 V, 0.5 A or 1 A. However, SO₄²⁻ concentrations in the lower part of the brick samples did not decrease even when the energization was applied under 0.5 A or 1 A, which were

effective in desalination for the upper part of the brick samples, suggesting that SO₄²⁻ ions were not removed in the lower part of the brick samples and the desalination efficiency was lower than that of the upper part.

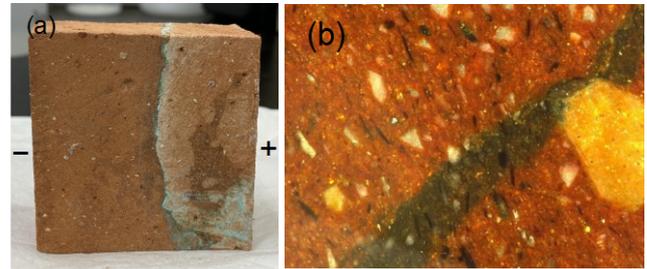
Figure 8: (a) The brick sample with the observed black area. (b) Enlarged photo of the black area.

The results of Test 2 are shown in Table 4. For Sample I, where water was added during the test, a black area formed (Figure 8), and salt was generated on the surface from the black area to the anode side. However, salt did not precipitate from the cathode side to the black area, and surface conditions were good. For Sample II, where no water was added during the test, no black area formed. Furthermore, salt precipitation was observed throughout the brick sample, although it was reduced.

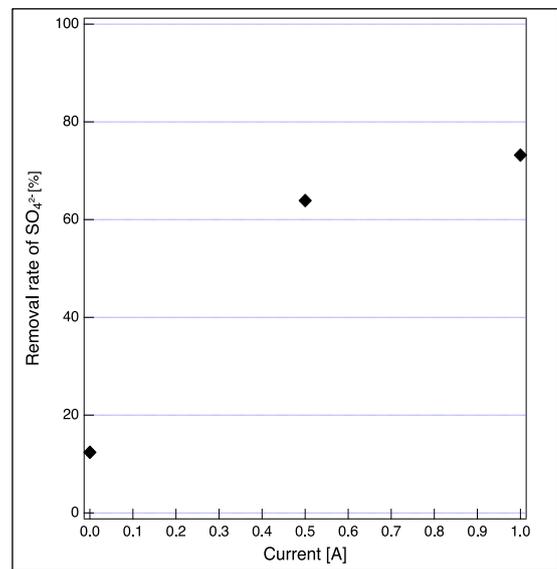
Figure 9: Change in removal rate of SO_4^{2-}

of ED, the removal rate of SO_4^{2-} concentration in the brick sample was calculated using the weight change of the electrodes before and after energizing and the molecular weight of $\text{CuSO}_4 \cdot 5\text{H}_2\text{O}$. Results indicate that when sufficient water was supplied to the brick sample, approximately 64% of SO_4^{2-} in the brick sample was removed when the energization conditions were 5 V and 0.5 A. Moreover, 73% of SO_4^{2-} ions were removed when the energization conditions were 5 V, 1 A (Figure 9). When a current of 0.5 A was applied, the removal rate of SO_4^{2-} increased by approximately 5 times compared to the removal rate when there was no current. However, when the current increased to 1 A, which is twice as large as 0.5 A, the removal rate dropped to about 1.1 times, and no significant differences were observed. Consequently, it is possible that the removal rate increases significantly when the current is up to 0.5 A, but that the relationship between the removal rate and the current value is low when the current is higher than 0.5 A. Since the number of samples tested was small in this iteration, it is necessary to increase the number of tests in the future and discuss subsequently. Although these removal rates are lower than the results of previous studies, visual observations showed that salt precipitation and deterioration of the brick surface could be reduced even after a current was applied, suggesting that ED current conditions are effective in inhibiting deterioration caused by salt weathering. At the same time, this ED model is expected to be suitable for Japanese historical bricks, which have varied characteristics, because it is possible to adjust the amount of water supplied during the energization by using an easily removable powdered cellulose for the electrode, and desalination can be performed without damaging the brick surface. In addition, the continuous fixation of $\text{CuSO}_4 \cdot 5\text{H}_2\text{O}$ on the copper plate of the anode caused even the Arbocel installed on the electrode to turn blue, and the migration of SO_4^{2-} to the electrode during energization could be visually confirmed. This is one of the advantages of using copper plates as electrodes. However, under energizing conditions where the desalination effect was observed, the efficiency of desalination at the lower part of the brick sample was low, suggesting that the length of the electrode was insufficient for the brick sample. Moreover, even though the energizing conditions for B1 and B2 were the same, visual observation after energizing showed a slight precipitation of salt in B2. This indicates that the reproducibility of the test may be insufficient.

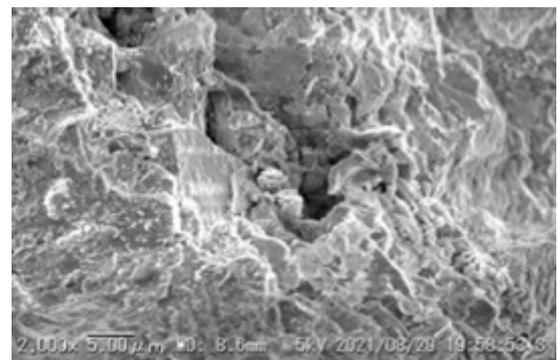
Figure 10: SEM image of the black area

Visual observation of Tests 1 and 2 showed a black area forming in the brick samples after energization. The black area was observed using scanning electron microscopy (SEM). Objects that appear particles were observed, as shown in Figure 10. Moreover, Cu_2O (Cuprite) was detected with X-ray diffraction analysis of

this area. According to Kawanishi, Cu_2O is formed in neutral aqueous solutions near room temperatures [20]. The pH of the area where the black part was formed was found to be 6.2, which is close to neutral. Additionally, it has been pointed out that metal elution occurs at the metal surface during the electrochemical process [21]. Therefore, it is possible that Cu^+ ions leached from the copper plate used as the electrode during the ED test and flowed into the brick sample.
